**Flood Control Project Maintenance
Levee Inspections**

2011 Channel Summary Report

San Joaquin County Flood Control and Water Conservation District

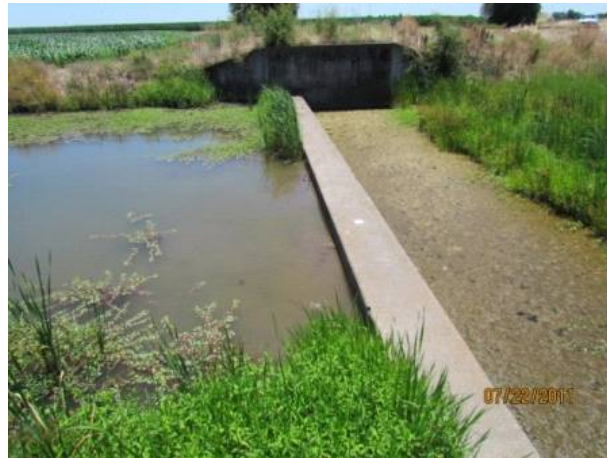
Levee Mile Report Line	1
Start Levee Mile	
End Levee Mile	
Location	
Category	Channels
Item	Vegetation & Obstructions

View of the vegetation in the channel downstream of the diversion channel.

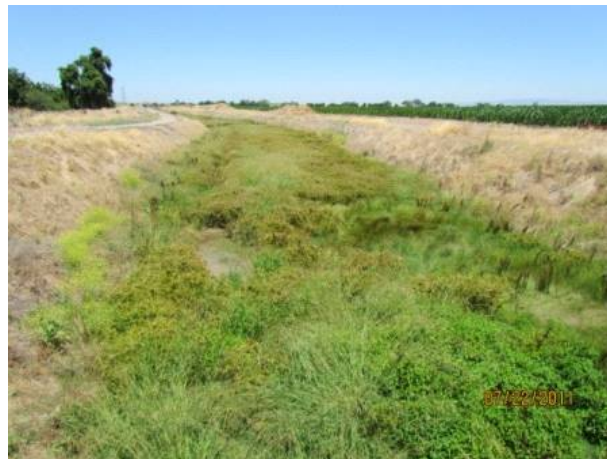
Levee Mile Report Line	5
Start Levee Mile	0.00
End Levee Mile	0.00
Location	
Category	Channels
Item	Vegetation & Obstructions

View of the vegetation growth on upstream of the channel.

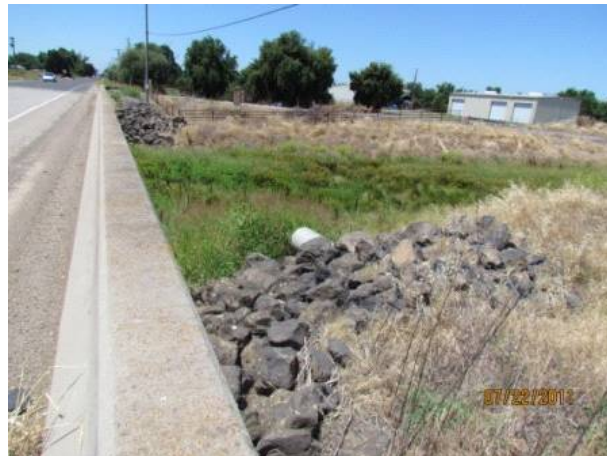
Levee Mile Report Line	8
Start Levee Mile	0.00
End Levee Mile	0.00
Location	
Category	Channels
Item	Revetments

View of the revetments on the upstream end of the channel.

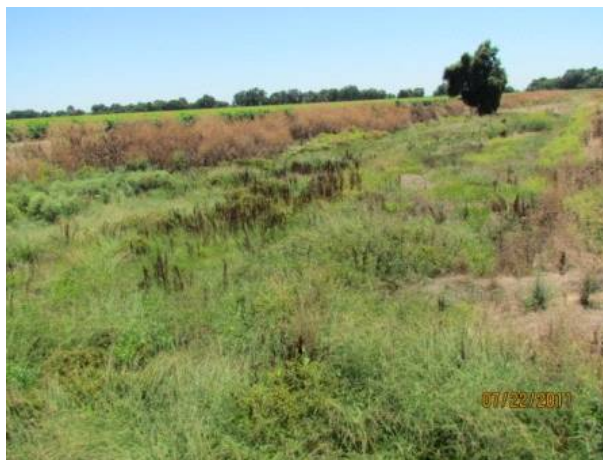
Levee Mile Report Line	10
Start Levee Mile	0.00
End Levee Mile	0.00
Location	
Category	Channels
Item	Vegetation & Obstructions

View of the vegetation growth on downstream of the channel.

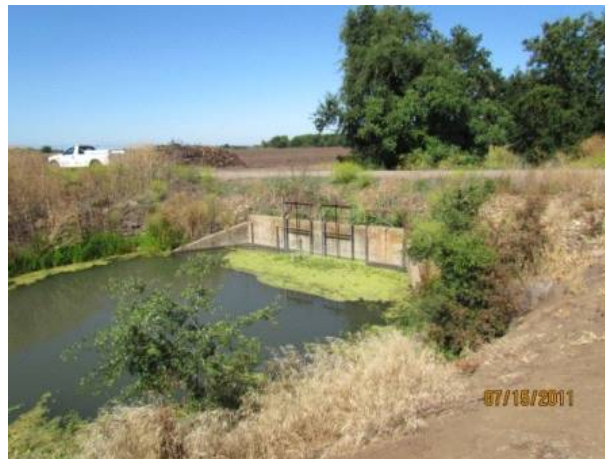
Levee Mile Report Line	11
Start Levee Mile	
End Levee Mile	
Location	
Category	Channels
Item	Concrete Surfaces

View of the concrete surface of the culvert looking from the upstream end of the channel.

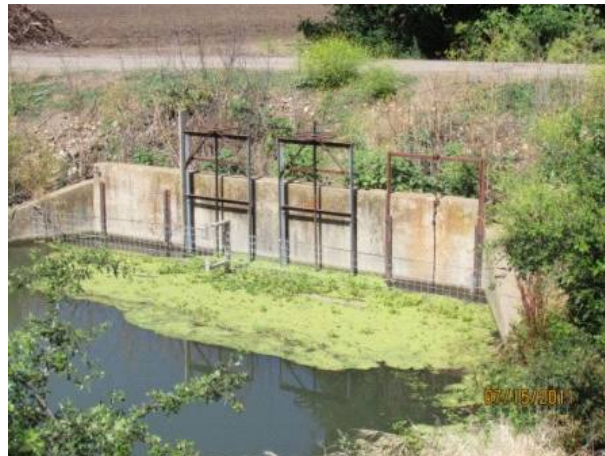
Levee Mile Report Line	12
Start Levee Mile	
End Levee Mile	
Location	
Category	Channels
Item	Gates

View of the gates looking upstream of the channel.

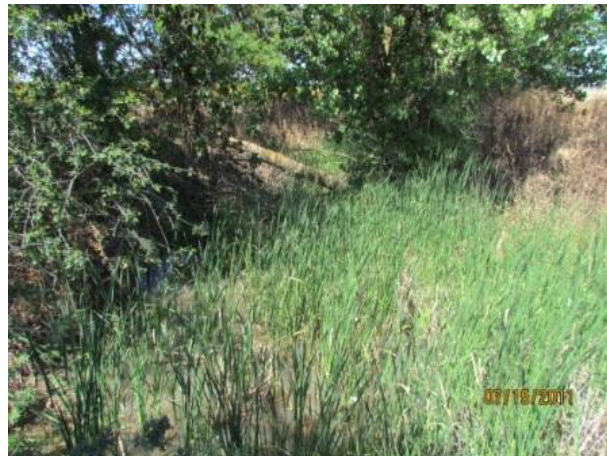
Levee Mile Report Line	43
Start Levee Mile	0.00
End Levee Mile	0.00
Location	
Category	Channels
Item	Vegetation & Obstructions

View of the vegetation growth taken from downstream end of the channel.

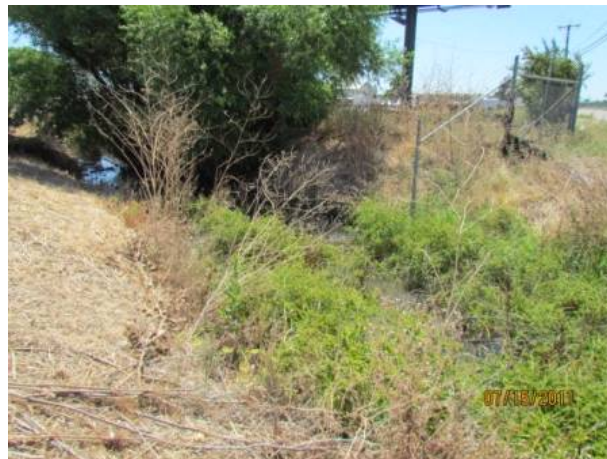
Levee Mile Report Line	52
Start Levee Mile	0.00
End Levee Mile	0.00
Location	
Category	Channels
Item	Encroachments

View of the encroachments on the channel and it was taken from the upstream end of the channel.

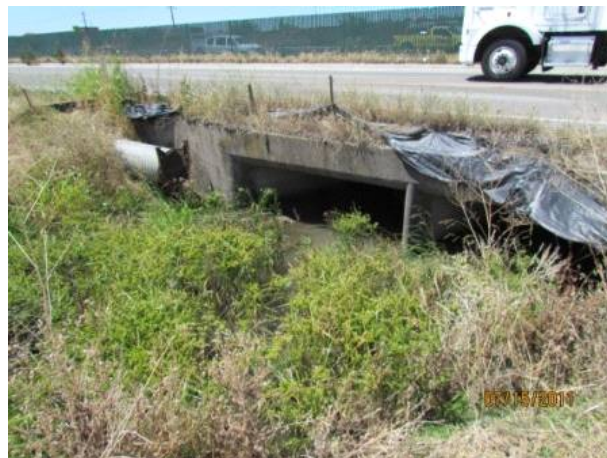
Levee Mile Report Line	57
Start Levee Mile	0.00
End Levee Mile	0.00
Location	
Category	Channels
Item	Encroachments

View of encroachments looking from the downstream of the channel.

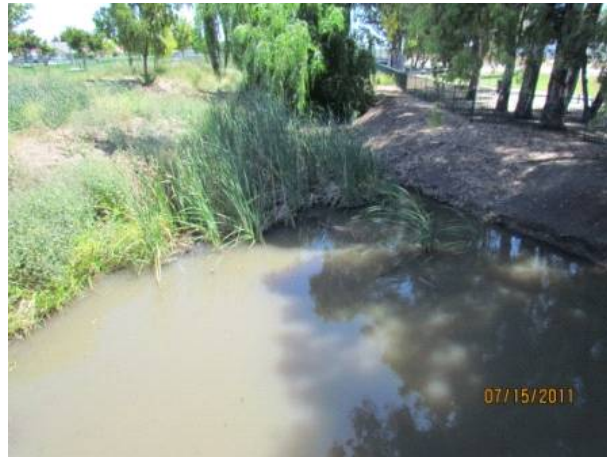
Levee Mile Report Line	63
Start Levee Mile	0.00
End Levee Mile	0.00
Location	
Category	Channels
Item	Vegetation & Obstructions

This picture is showing the upstream end of the channel and the vegetation growth at that location.

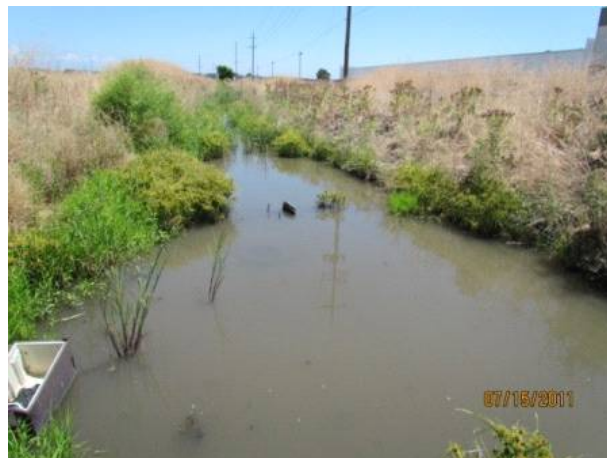
Levee Mile Report Line	68
Start Levee Mile	0.00
End Levee Mile	0.00
Location	
Category	Channels
Item	Vegetation & Obstructions

View of the vegetation at the downstream of the channel.

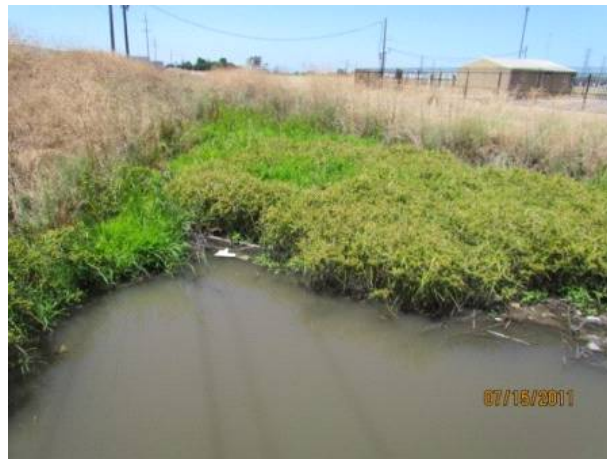
Levee Mile Report Line	73
Start Levee Mile	0.00
End Levee Mile	0.00
Location	
Category	Channels
Item	Vegetation & Obstructions

This picture was taken from the downstream end of the channel and the channel had minimal vegetation growth.

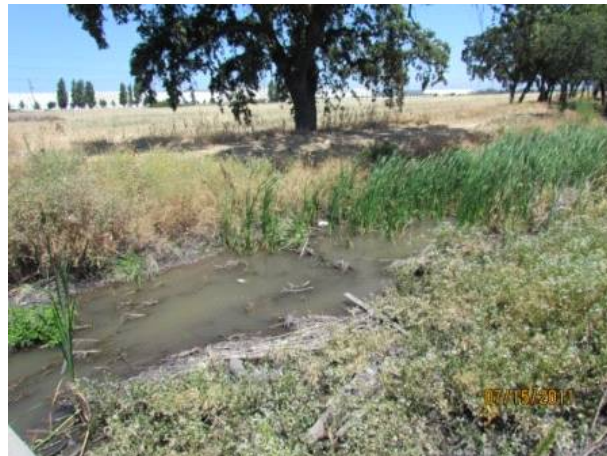
Levee Mile Report Line	78
Start Levee Mile	0.00
End Levee Mile	0.00
Location	
Category	Channels
Item	Vegetation & Obstructions

This picture shows the upstream end of the channel with vegetation growth.

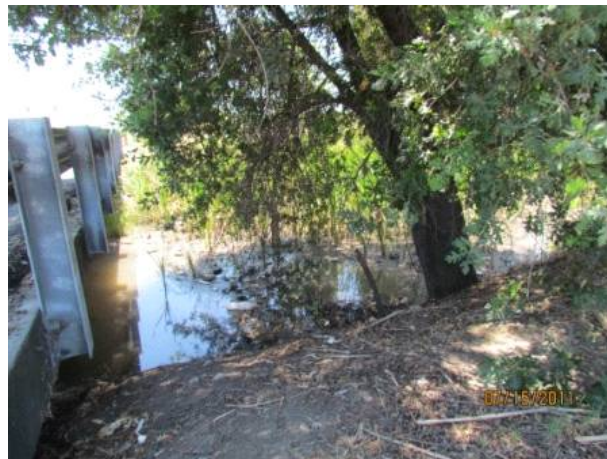
Levee Mile Report Line	83
Start Levee Mile	0.00
End Levee Mile	0.00
Location	
Category	Channels
Item	Vegetation & Obstructions

The picture was taken from downstream end of the channel showing the vegetation growth.

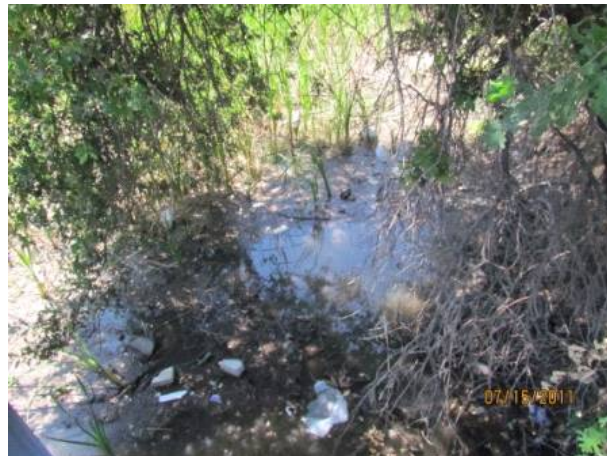
Levee Mile Report Line	87
Start Levee Mile	0.00
End Levee Mile	0.00
Location	
Category	Channels
Item	Encroachments

This picture was taken from downstream end of the channel looking at the encroachments.

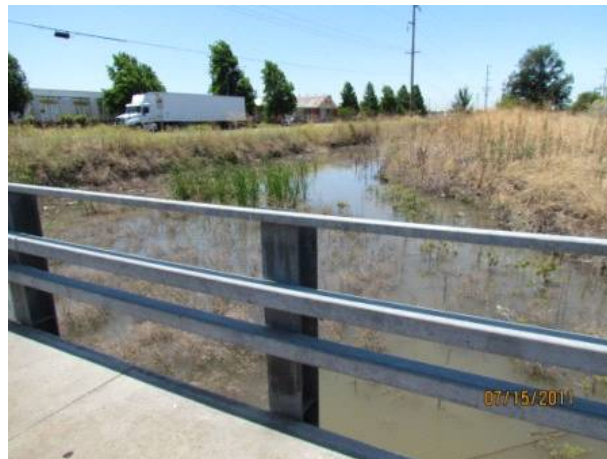
Levee Mile Report Line	93
Start Levee Mile	0.00
End Levee Mile	0.00
Location	
Category	Channels
Item	Vegetation & Obstructions

This picture shows the minimal vegetation growth on the upstream end of the channel.

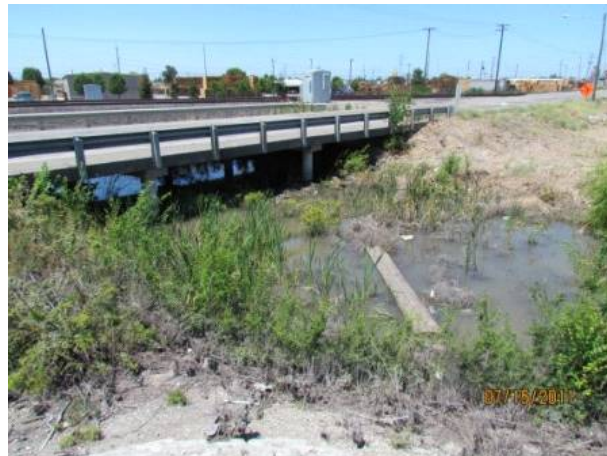
Levee Mile Report Line	98
Start Levee Mile	0.00
End Levee Mile	0.00
Location	
Category	Channels
Item	Vegetation & Obstructions

This picture shows downstream of the channel with vegetation and other obstructions.

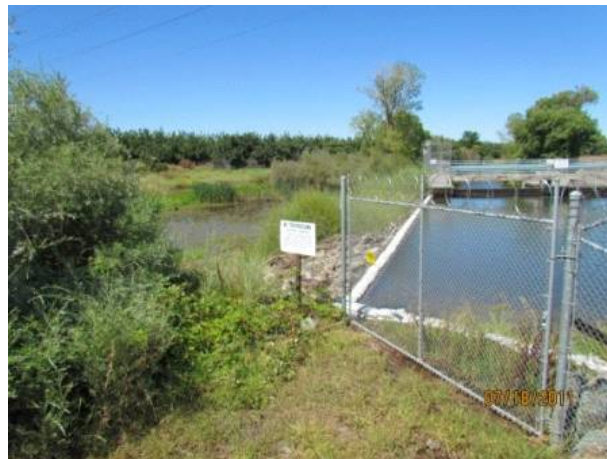
Levee Mile Report Line	4
Start Levee Mile	0.00
End Levee Mile	0.00
Location	
Category	Channels
Item	Revetments

View of the revetments looking downstream.

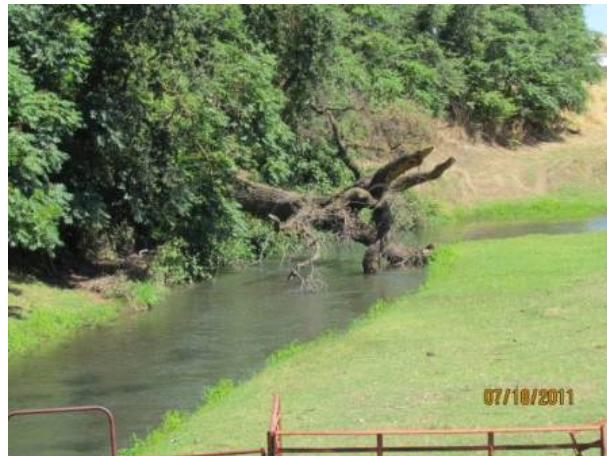
Levee Mile Report Line	6
Start Levee Mile	0.00
End Levee Mile	0.00
Location	
Category	Channels
Item	Vegetation & Obstructions

This picture shows a log is obstructing the flow of the channel. This picture was taken looking upstream .

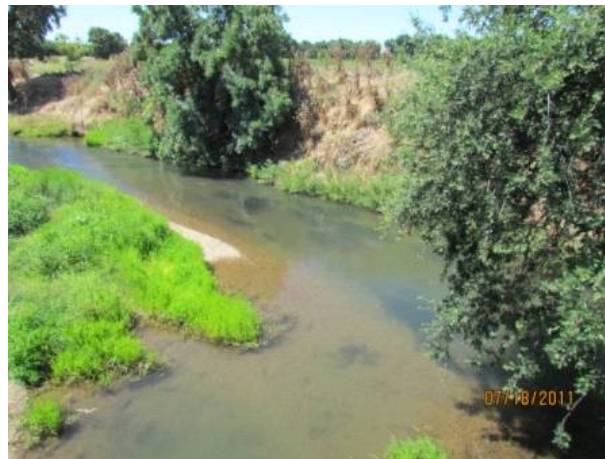
Levee Mile Report Line	11
Start Levee Mile	0.00
End Levee Mile	0.00
Location	
Category	Channels
Item	Vegetation & Obstructions

This photo shows the vegetation growth on the downstream of the channel.

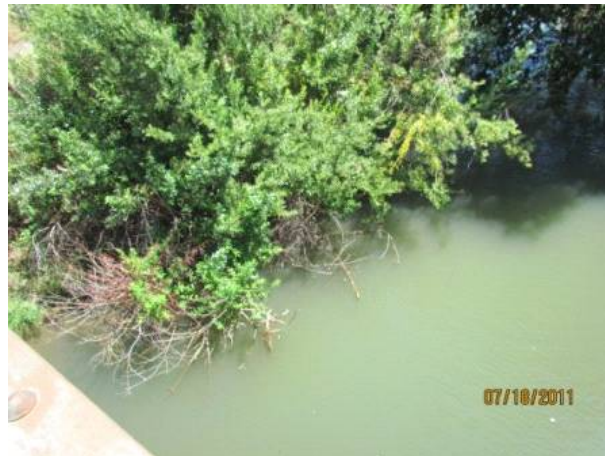
Levee Mile Report Line	16
Start Levee Mile	0.00
End Levee Mile	0.00
Location	
Category	Channels
Item	Vegetation & Obstructions

This picture shows the vegetation growth that could impede the flow of the channel looking upstream.

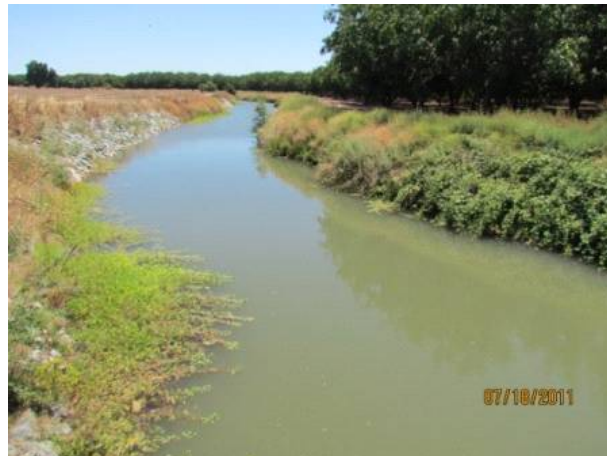
Levee Mile Report Line	26
Start Levee Mile	0.00
End Levee Mile	0.00
Location	
Category	Channels
Item	Vegetation & Obstructions

This picture shows the minimal vegetation growth which doesn't impede the flow in the upstream of the channel.

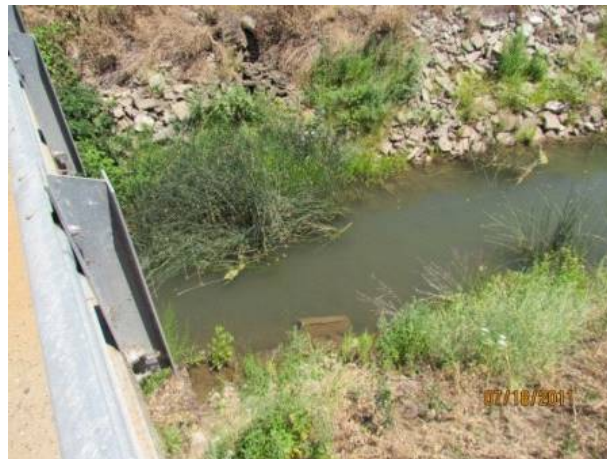
Levee Mile Report Line	36
Start Levee Mile	0.00
End Levee Mile	0.00
Location	
Category	Channels
Item	Vegetation & Obstructions

This photo shows the vegetation growth and debris that could impede the flow of the channel looking upstream.

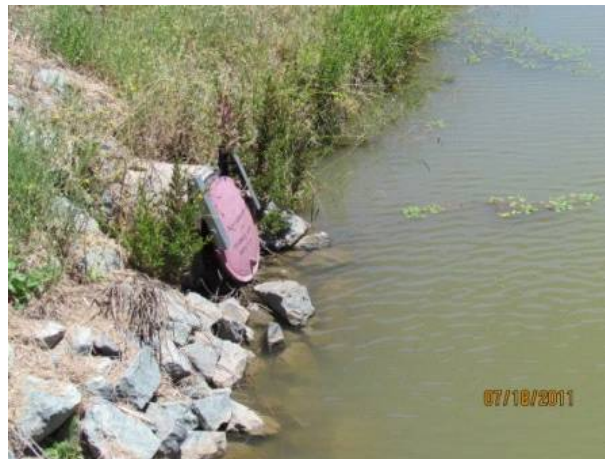
Levee Mile Report Line	60
Start Levee Mile	0.00
End Levee Mile	0.00
Location	
Category	Channels
Item	Encroachments

View of the open flap gate looking upstream.
